NOTRE DAME ROCKET TEAM
FLIGHT READINESS REVIEW ADDENDUM

NASA STUDENT LAUNCH 2019
UAV AND AIR BRAKING PAYLOADS

Submitted March 25, 2019

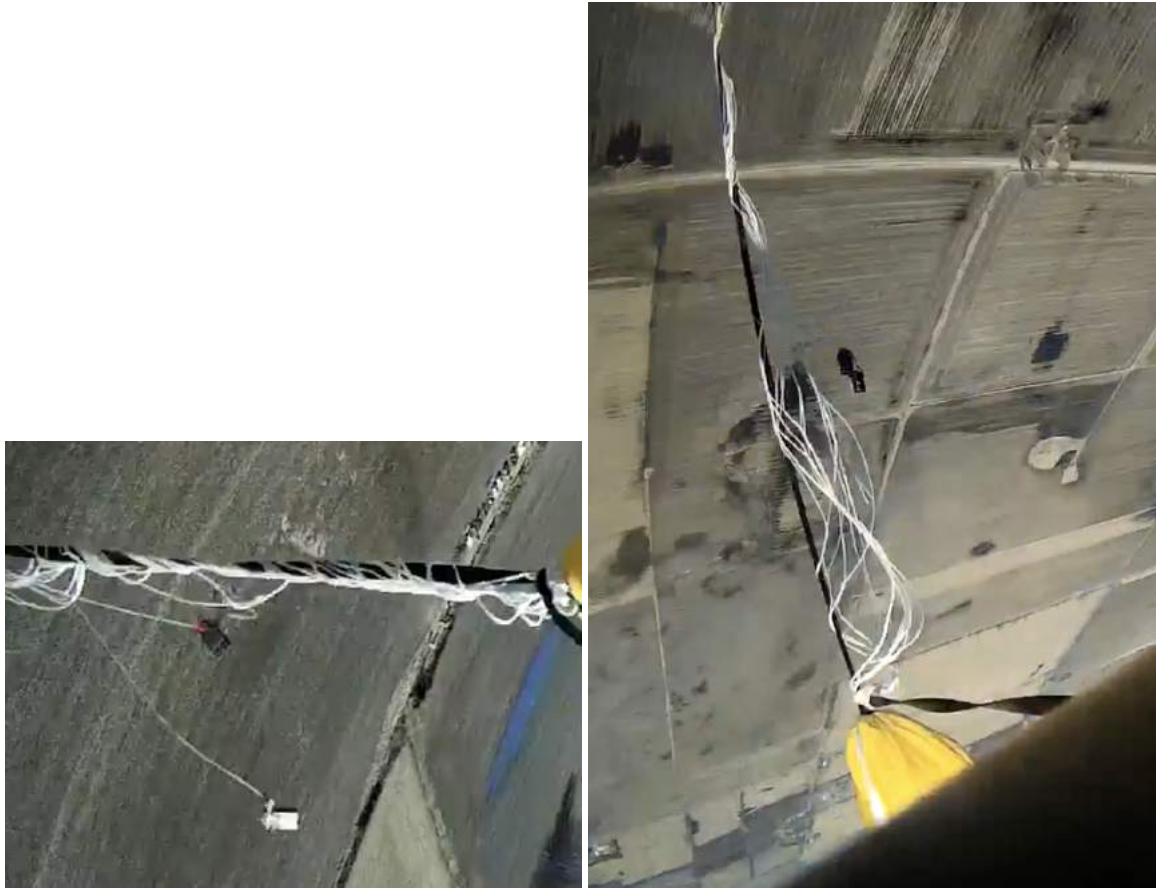
The deployment system functioned correctly, which causes the main and drogue parachutes to be ejected from the rocket at apogee. In addition, video from the transition section of the rocket provided visual confirmation that the Jolly Logic Chute releases remained connected until 500ft AGL at which point they released. Figures of the Jolly Logic Chute releases connected and unconnected during flight are shown in Figure 1.

Figure 1: Chute Releases with different configurations during flight

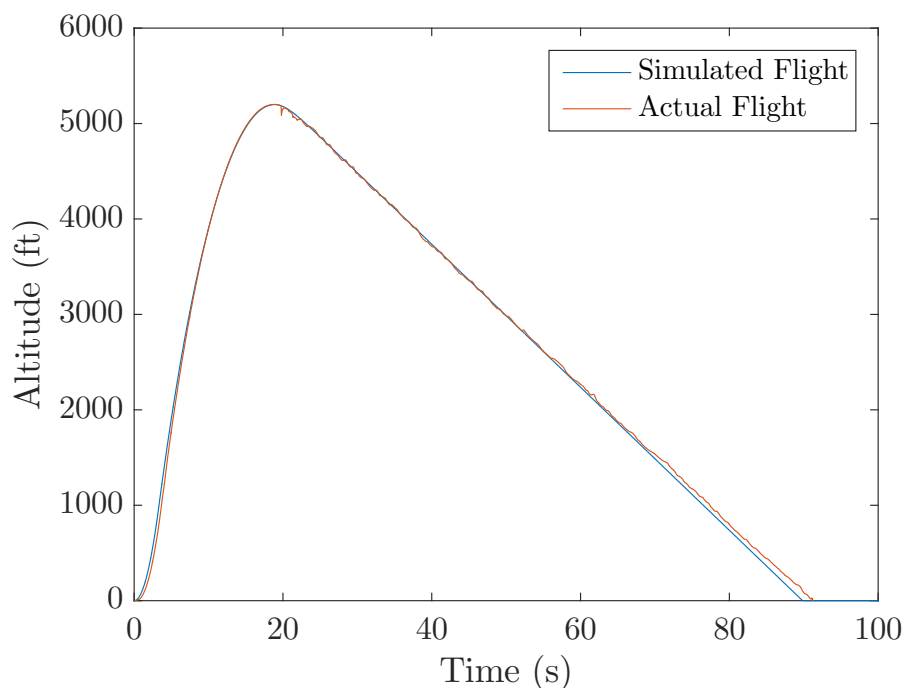
From this model an overall drag coefficient of the rocket was found to be approximately 0.182. This was used to run a post flight simulation using an Euler method simulation written in a Matlab script for descent under drogue only. The result of this is shown in Figure 3. As shown, the Euler method simulation nearly perfectly models the experimental flight, which gives confidence in the ability of the team to model future flights using this tool.

Figure 3: Simulated flight compared to measured flight

The predicted maximum velocities were 11.01% and 11.11% lower than measured, which is possibly due to noise in the signal. The maximum acceleration was an order of magnitude greater than predicted. This was due to the large acceleration at landing, which was not accounted for in pre-flight simulations. However, post flight simulations were able to account for this and provide an estimated kinetic energy at landing of within 2% of measured during flight.

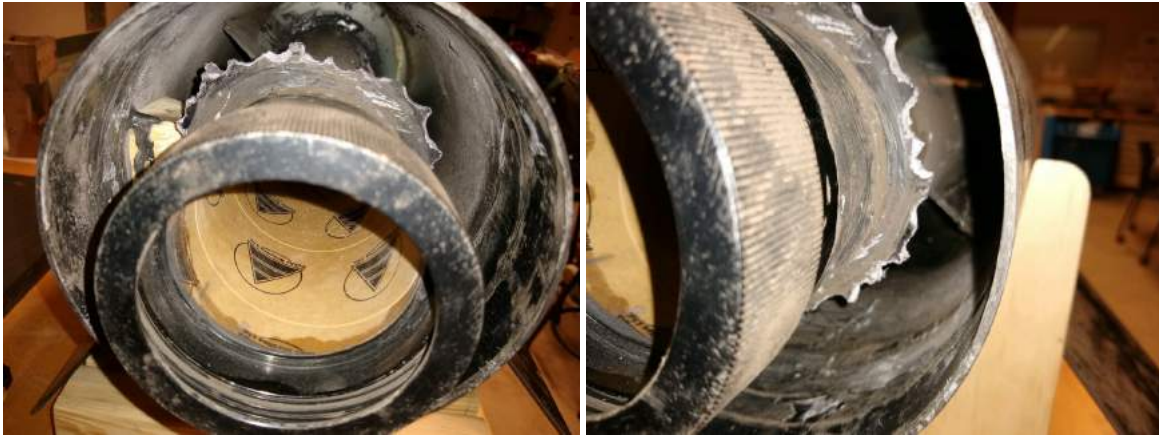
Upon vehicle impact, the off-nominal forces of landing bent one side of the aft centering ring in the body tube and cracked the epoxy adhering it to the fin can. This is problematic for two reasons, (1) the centering ring being skewed in the airframe induces tension on the motor mount that prevents the removal of the motor casing, and (2) the centering ring is no longer structurally sound. The team deemed it necessary to remove this centering ring through various methods of drilling and use of a Dremel to separate it from the airframe. A portion of the ring attached to the motor mount was left in order to provide a guide and additional structural support for a new aft centering ring to be integrated. This process can be seen in Figure 4, below.

Figure 4: Centering Ring post-removal

The new centering ring must fit directly onto the motor mount, however, the motor retainer has a larger outer diameter than the motor mount. Since the motor retainer adaptor cannot be removed, the inner diameter of the centering ring must increase to provide clearance. This creates a gap between the centering ring and motor mount tube. The team will resolve this by filling the gap with duct seal covered in JB Weld epoxy. The new centering ring will then be located above this base and braced against the portion of the old centering ring remaining in the airframe. This provides sufficient structural support for the fin can. It is worth noting that the motor mount itself did not move during the landing, nor were any other centering rings damaged. Therefore, it will be sufficient to use a new centering ring, and use the remains of the old ring as a crutch and a guide.

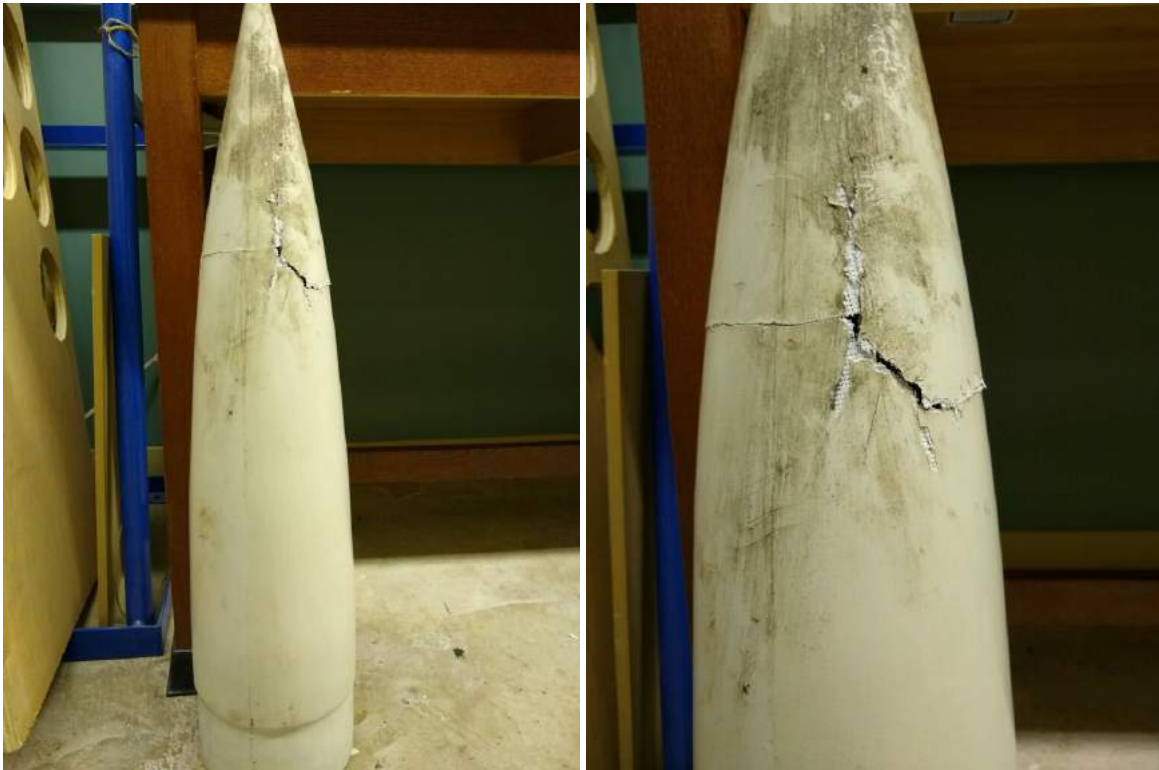
The fore section of the separated rocket landed directly on the nose cone causing significant cracking damage of the nose cone. The nose cone was deemed irreparable due to the extent of the damage, so a new, identical nose cone has been ordered. The damage received by the nose cone is shown in Figure 6

Figure 6: Nose Cone Damage

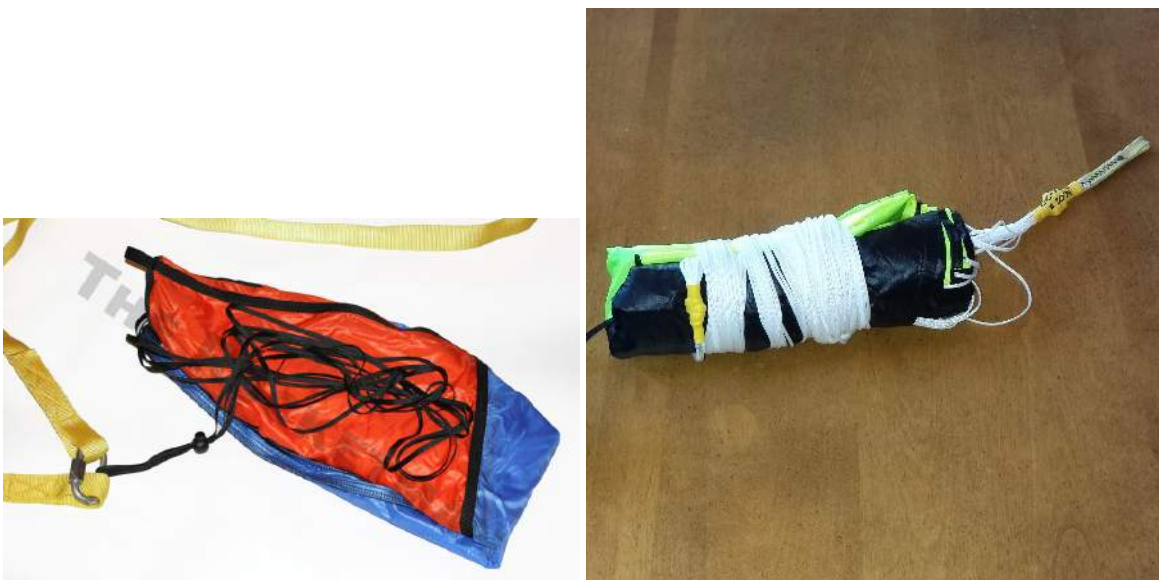
Figure 9: As launched packing (left) vs. the new packing method (right) Photos courtesy of Rocketman Enterprises and Fruity Chutes Inc.

In order to mitigate the failure mode which caused main deployment at apogee on the March 2 launch, the parachute will be packed such that the shroud lines are wrapped around the bundled parachute. This prevents the shroud lines from being pulled out of the parachute bundle when the shock cord is pulled. Finally, The Jolly Logic Chute Releases will be tied directly around the parachute, instead of around the Nomex protector. This will mitigate the risk of main deployment being induced from separation of the packed chute from the Nomex bundle and will ensure a more secure fit during ejection. A comparison of the two folding methods are shown in Figure 9.

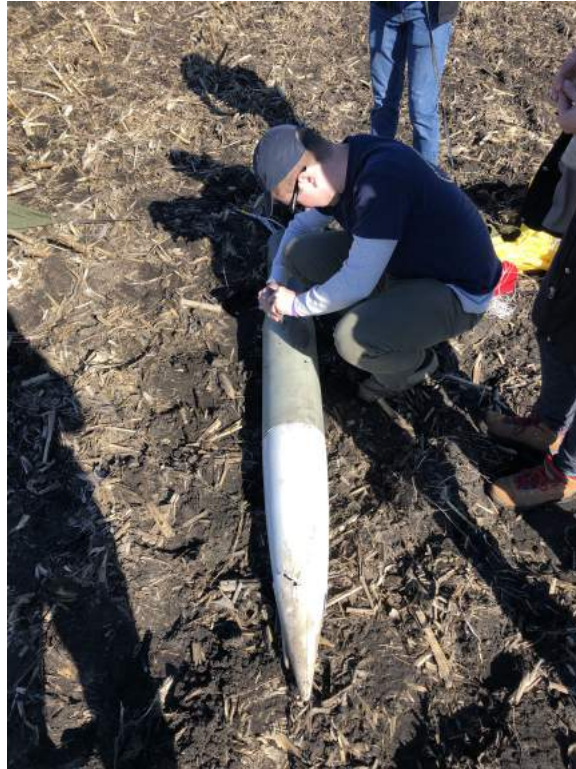
The leadscrew is the only component attaching the nose cone to the payload bay and is responsible for its retention. Because the nose cone remained attached to the payload bay throughout launch and recovery, this system is determined to be successful in retaining the payload. Additionally, the deployment mechanism is secured to the airframe via six screws running through the payload bay into the aft bulkhead of system. These screws show no evidence of yielding or significant wear after the flight. The payload components (deployment, UAV, nose cone, and platform) all therefore are shown to be properly retained. The payload bay post launch and recovery may be seen in Figure 11.

Figure 11: Nose cone still securely attached.

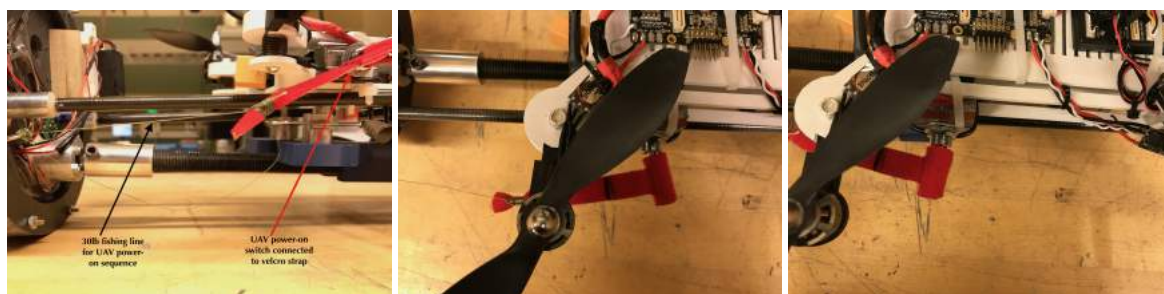
Because the UAV was not deployed during the launch on March 23rd, the R-clips were never pulled from the struts of the UAV. However, the R-clips were successful in keeping the UAV restrained for the entirety of launch and recovery. Successful activation of the UAV also occurs during linear translation. Similar to the disengagement of the UAV, fishing line attached to the aft bulkhead becomes taut as the UAV moves forward, thus pulling the switch on the UAV and powering on the drone. Photos of this process are found in Figure 13.

Figure 13: UAV power-on sequence before and after Linear Transport.

Because the UAV was not deployed yesterday, the UAV was never powered on. However, this mechanism was successful in preventing the premature activation of the UAV for the entirety of launch and recovery. It is therefore shown, that for the duration of the flight, all UAV components were successfully retained and the UAV remained in a powered off state.

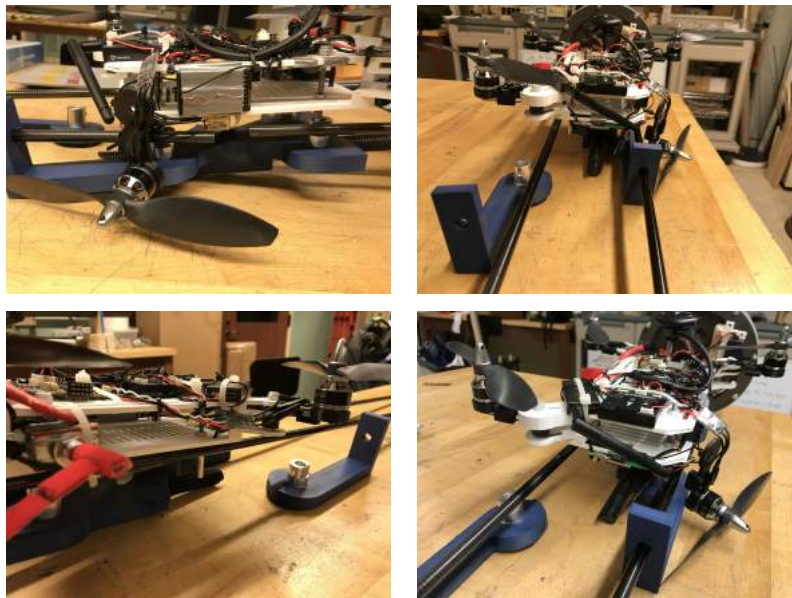
As a result of the impact at landing the following hardware experienced structural failures which are also shown in Figure 14:

Figure 14: Broken hardware for this year's scoring payload.

- The nylon leadscrew was sheared just aft of the nose cone. A replacement for this component has already been ordered from McMaster Carr. This component will remain unchanged only replaced.
- Carbon Fiber rod aiding in orientation correction to rotate the sled broke. A replacement has been ordered from Rock West Composites and remaining material in the aluminum flange shall be drilled out in order to avoid milling a new nylon bulkhead.
- A single drone platform arm broke. There exists funds in the budget to 3D print a replacement within 3 business days from the Innovation Park at Notre Dame. The current component can also be repaired using JB Weld epoxy and a dowel rod insert for added structural integrity.
- Drone platform itself experienced a single arm breaking. A replacement shall also be 3D printed at Innovation Park.

As far as flight and payload mission go, the drone will be reprinted with 100% infill at Innovation Park at Notre Dame to prevent the arm from fracturing again. The other subsystems in the payload shall be further tested for intended functionality. Additionally, FEA data will continue to be gathered via laptop as the drone itself is being rebuilt and mounted to continue to improve the. Once the drone is remade (by Thursday, March 28), the team will fly it and continue to test the Beacon Deployment Subsystem.

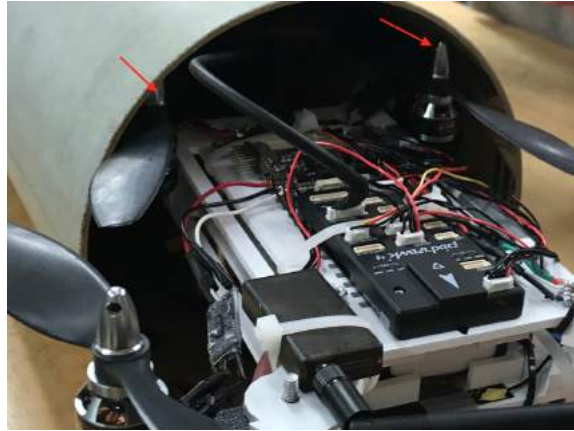
The R-clip driven retention mechanism was successful in keeping the entire drone attached to the platform throughout the entirety of flight. The broken arm most likely fractured due to the way the drone sits inside the payload bay. Its arms and props rest against the inner wall of the body tube, so impact at 87 G's exceeded its shear strength. A figure showing the interface between the props and the inner wall of the body tube is the following, Figure 15.

Figure 15: Red arrows highlight the points where the drone touches the inner wall of the body tube.

In the future, the motor caps shown in Figure 15 will be replaced with lock nuts. Since the lock nuts are shorter, they will not rest against the inner wall of the payload bay. This will help extricate the prop arms as much as possible from launch vehicle wall vibrations during flight. It is worth noting that, while the other broken components (leadscrew, the carbon fiber tube, and the platform) experienced failures, all were previously flown on the March 2 launch and were successful. Thus, these components will not be changed during rebuilding.

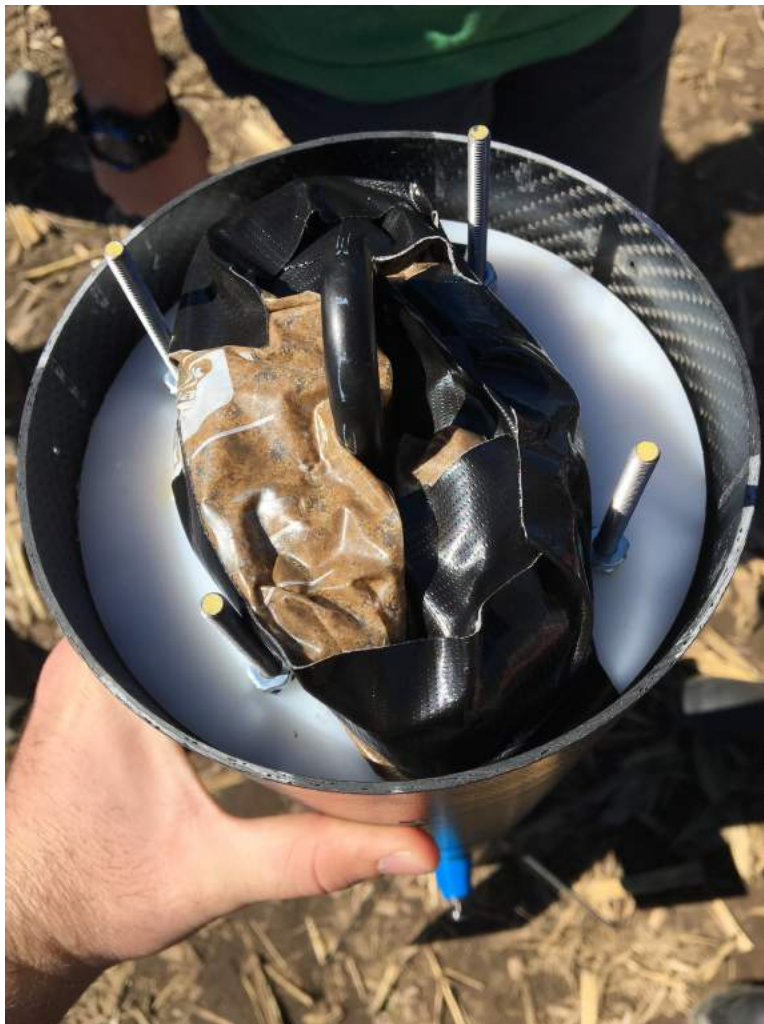
Figure 16: ABS Integration and Ballast

The payload retention system for the Air Braking System (ABS) consists of 4 steel threaded rods epoxied to a bulkhead in the fin can. These rods are positioned to align with holes cut in the ABS bulkheads that secure the system and provide alignment of the drag tabs with the slots cut in the fin can. The threaded rods are secured using #10-32 hex nuts to lock in the top bulkhead of the payload.

The Air Braking System was also used to provide space for ballast. Ballast was placed in on the upper surface of the aft bulkhead of the system, and to the top of the fore bulkhead. These ballasts were secured using duct tape to the ABS component. The fore of the ABS retention and the ballast in that section are shown in Figure 16.

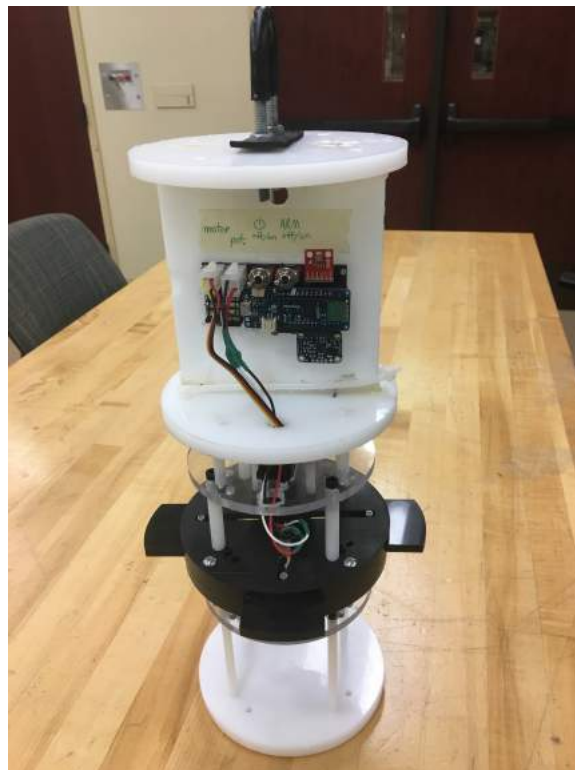
Figure 18: ABS Assembly

The ABS is a vehicle payload which implements a control system to assist the vehicle in reaching the designated apogee. The system progresses through 5 stages: waiting, liftoff, motor burnout, apogee, and landing. The system is designed to remain idle until motor burnout occurs, and then compare recorded altimeter and accelerometer values to a predicted ideal flight reaching the target apogee of 4,700 feet for a given mass and motor selection. At apogee, the system is to retract the tabs fully and they shall remain retracted for the remaining duration of the flight. Recorded flight data and state machine decisions are recorded on a microSD card. The Air Braking System as built is shown in Figure 18.

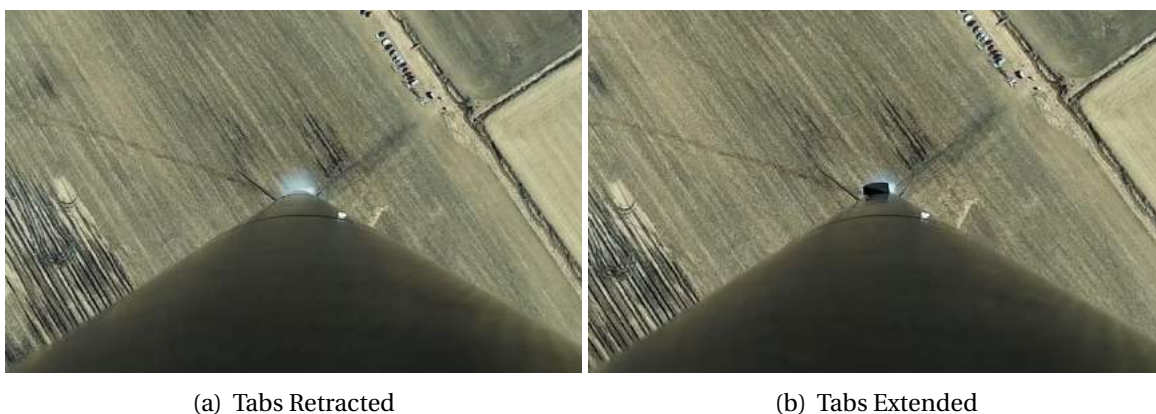
The ABS mechanism successfully functioned during flight. As shown in figure 19, the tabs were fully extended for a portion of the flight occurring after motor burnout. This demonstrated the operation of the mechanism and that the launch vehicle remained stable during this extension. However, due to a software error discussed later in this report the tabs were prematurely retracted and did not remain extended throughout the ascent phase of flight. As a result, the ABS had a limited impact on the recorded apogee when compared with the simulated results using OpenRocket and Rocksim. The mechanism has been ground tested following the flight and was shown to still be operational.

Figure 19: ABS tab actuation during flight

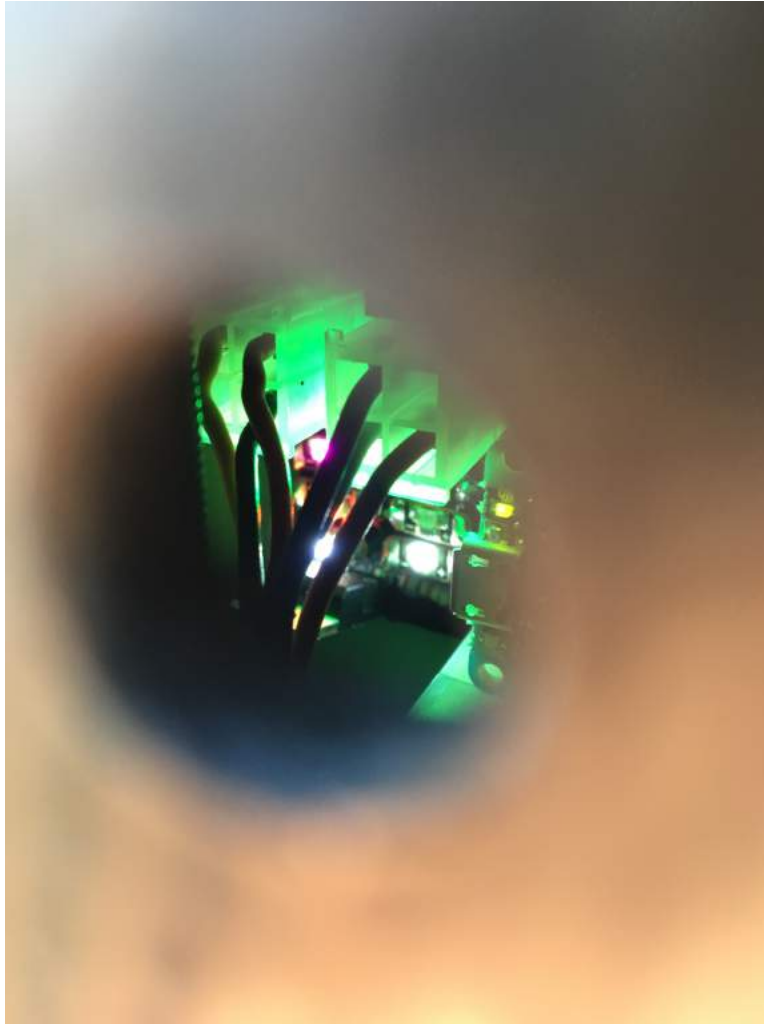
The ABS Electronics performed as expected. During pre-launch procedures, the power and status LEDs were properly illuminated, and the flight demonstrated the ability of the electronics to distribute power from the 7.4 V battery to the servo motor and Arduino-sensor system through a 5V voltage regulator. The servo motor and mechanism performed as designed and the system did not lose power during flight as indicated by the continuous data recorded on the SD card. The power and status LEDs were also observed through the vent holes to still be illuminated at the time of recovery, further indicating the system remained powered, as shown in figure 20. In order to mitigate issues with zip ties shearing during the first flight, the battery was retained in a custom 3D printed case epoxied to the electronics deck of the ABS. In addition to the case cover, the battery was secured by a velcro command strip and was successfully retained during flight. The new case is shown in Figure 21.

Figure 20: ABS Status LEDs at Recovery

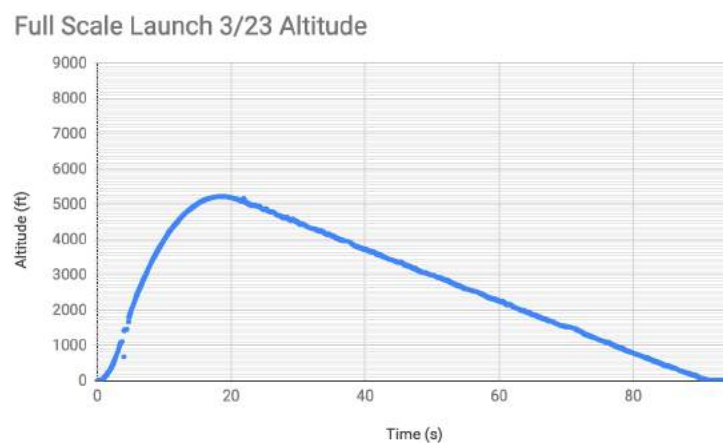
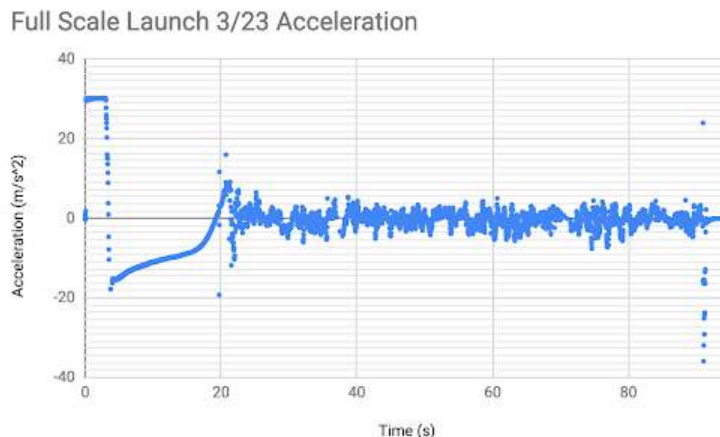
The recorded altitude and acceleration data are shown in Figures 22 and 23. The measured apogee by the ABS altimeter was 5,225 feet, which was 25 feet above the apogee recorded by the scoring recovery altimeter of 5,200 feet, representing a 0.48% difference.

Figure 22: ABS Recorded Altitude

Figure 23: ABS Recorded Vertical Acceleration

The software experienced one issue that resulted in a premature detection of apogee and retraction of the tabs. Following motor burnout, the software successfully detected the tabs needed to be deployed and extended them into the airflow. Following this, the altimeter recorded a single noisy data point with a drop of 400 feet from the previous value, tripping apogee detection. An oversight was made when making the decision to remove the Kalman Filter, which was meant to counter these types of noisy data points and was not replaced by a separate simpler filter. This resulted in the system continuing to rely on just one decrease in altitude reading to trigger detection of the apogee flight stage.

In order to mitigate the software detecting a premature apogee, two conditions will be added. The first is to check for numerous continuous samples of decreasing altitude and second is to incorporate the accelerometer in the decision. The latter is done by recognizing if the launch vehicle's axial acceleration has changed from the approximately negative 1 G at

burnout to a lower value as the fore of the vehicle begins to tip over at apogee.
